World class manufacturer of Aprons & Cots

This audit is done in a 100 % Viscose spinning mill in South India.

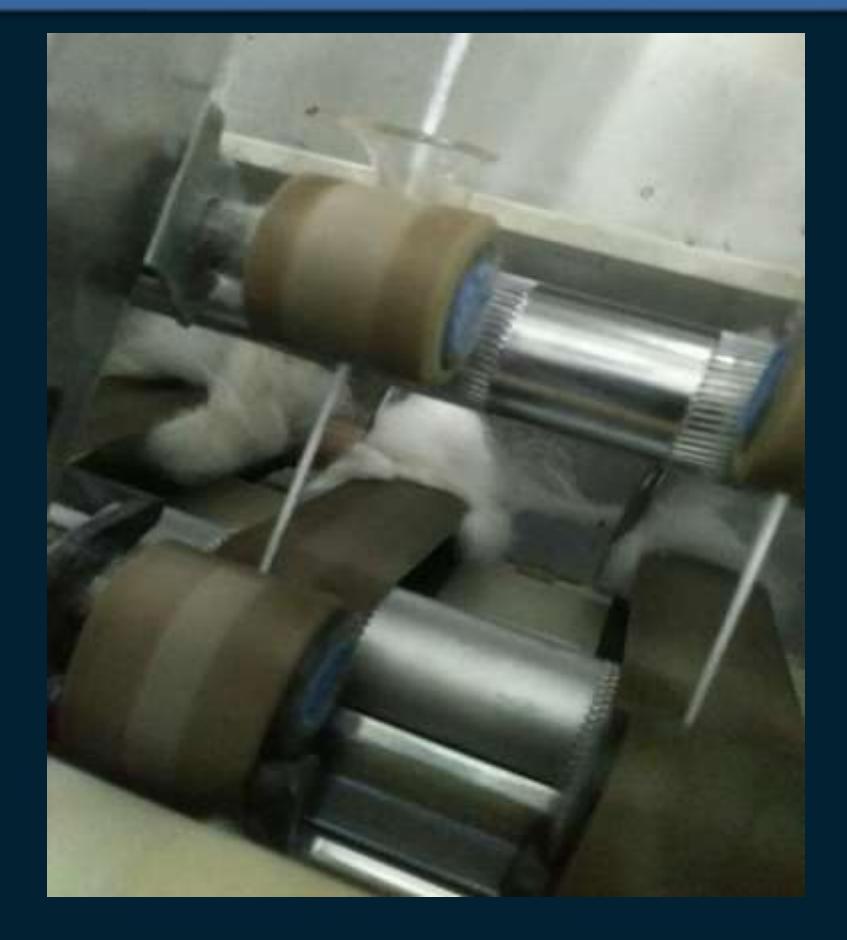
Fluff Accumulation on tension fork

In this case, the free rotation of apron gets obstructed and tends to get buckled inside the nose bar.

- **1**. The tension fork spring is to be cleaned by rust removing solution frequently.
- 2. Frequency of cleaning to be increased with respect to removal of fluff accumulation on fork, loaded roving ends in both tension fork and bottom clearer rollers.
- **3.** As the breaking strength is very high in Endless aprons, it was suggested to use more spare endless aprons in place of skived aprons.

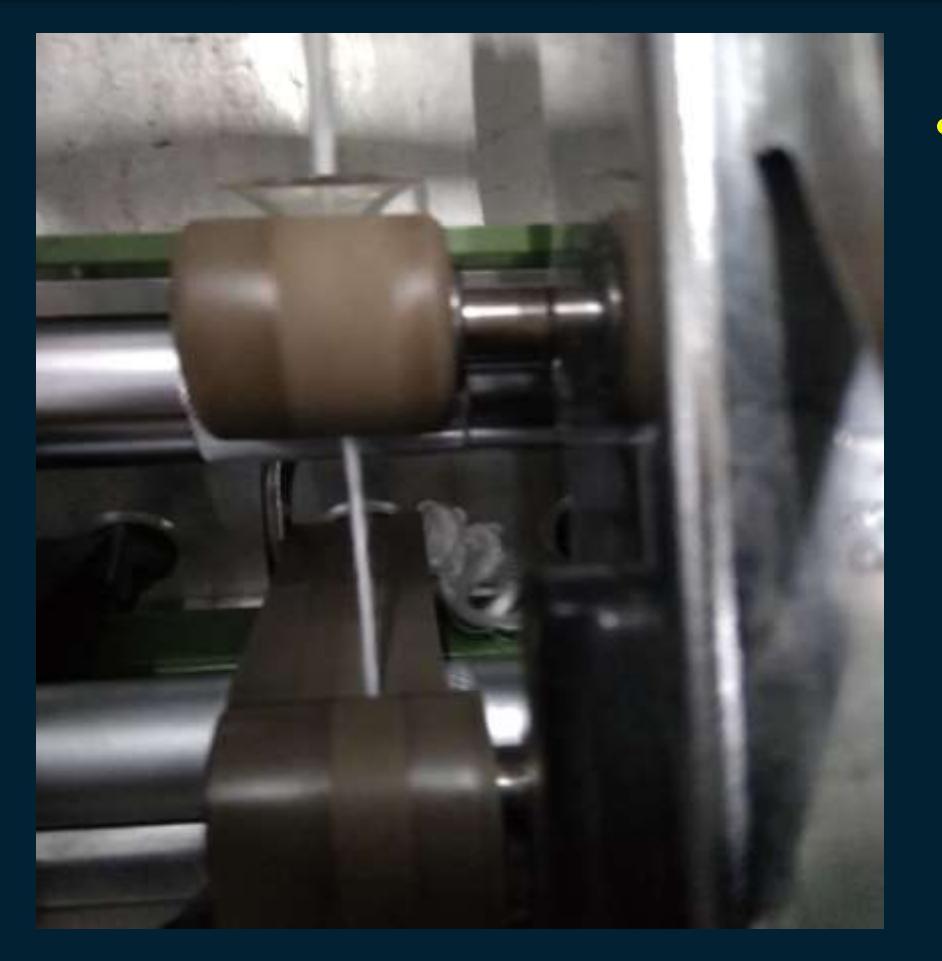
Roving Ends Loaded on Apron Tension fork

In this case, the free rotation of apron gets obstructed and tends to get buckled inside the nose bar.

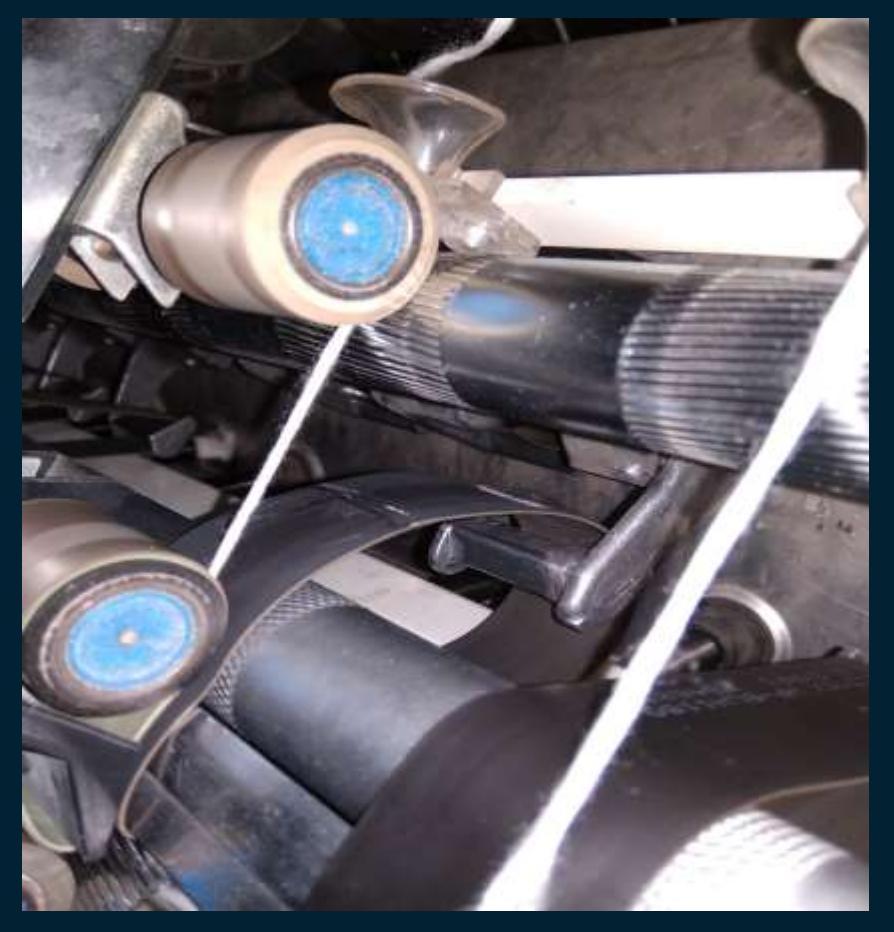
Non Reversal of Apron Tension Fork

- Spring tension on apron fork was found insufficient on continuous usage. Hence apron tension fork is getting obstructed and not able to swing to its original position.
- This leads to the buckling of bottom apron inside nose bar and ultimately resulting in apron breakage.

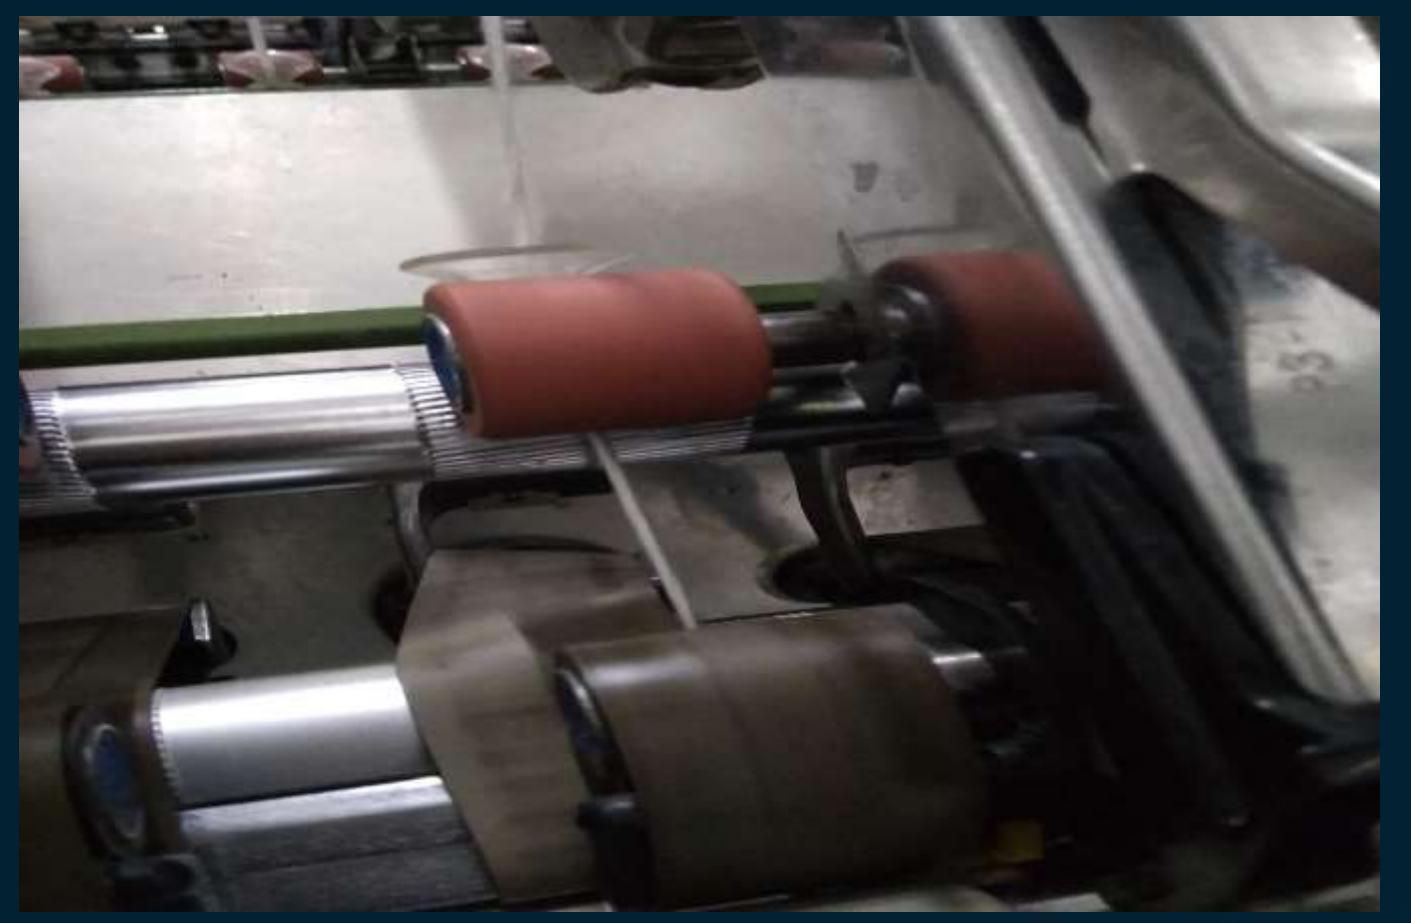
Apron sliding movement

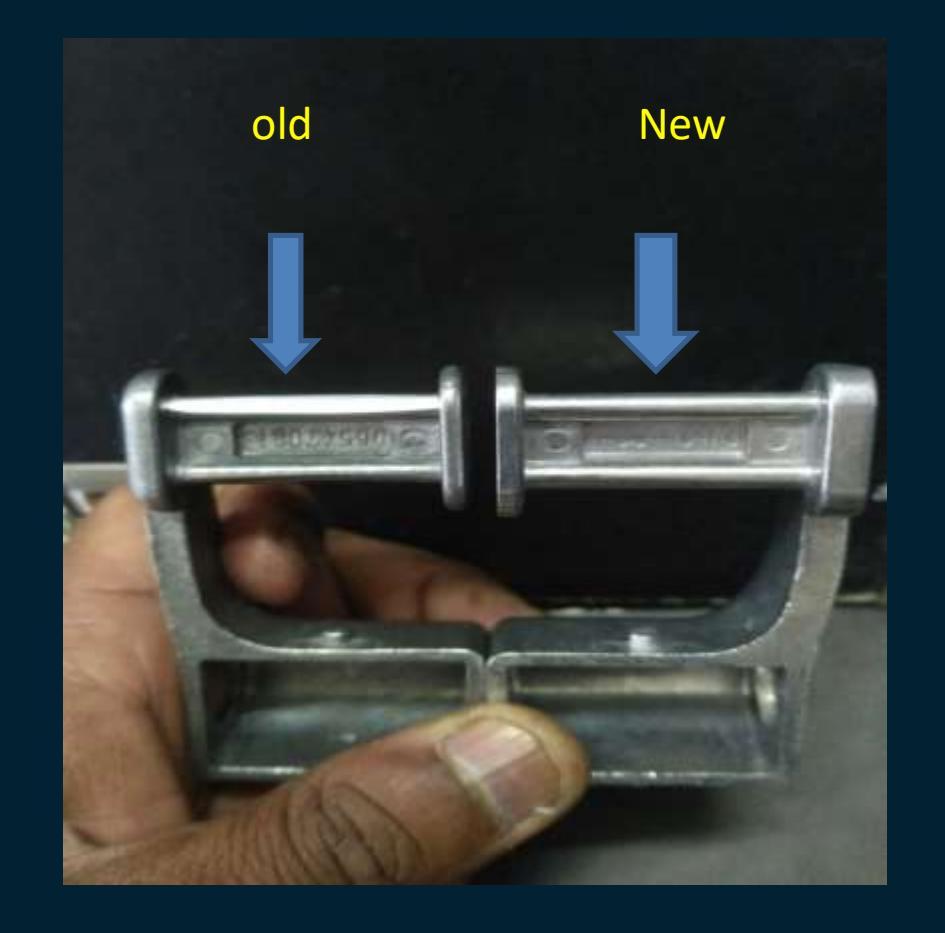
Condition of apron tension fork

Since the apron tension fork's condition is poor, it should be replaced by new one or a plastic cap is to be used to avoid apron damages.

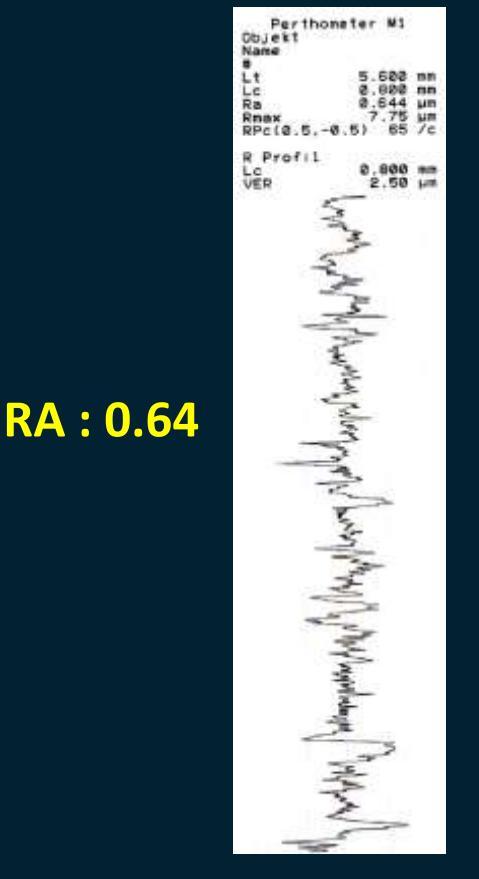
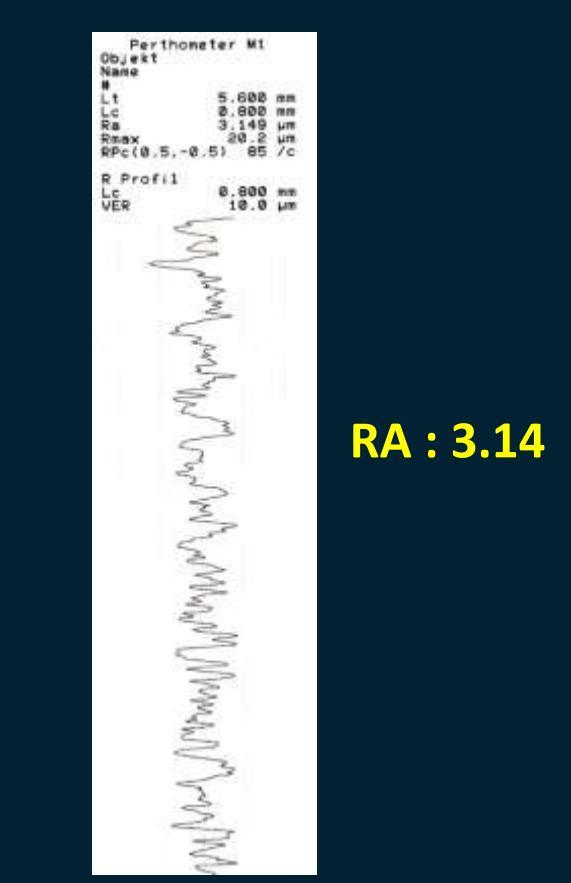
Good surface finish

Poor surface finish

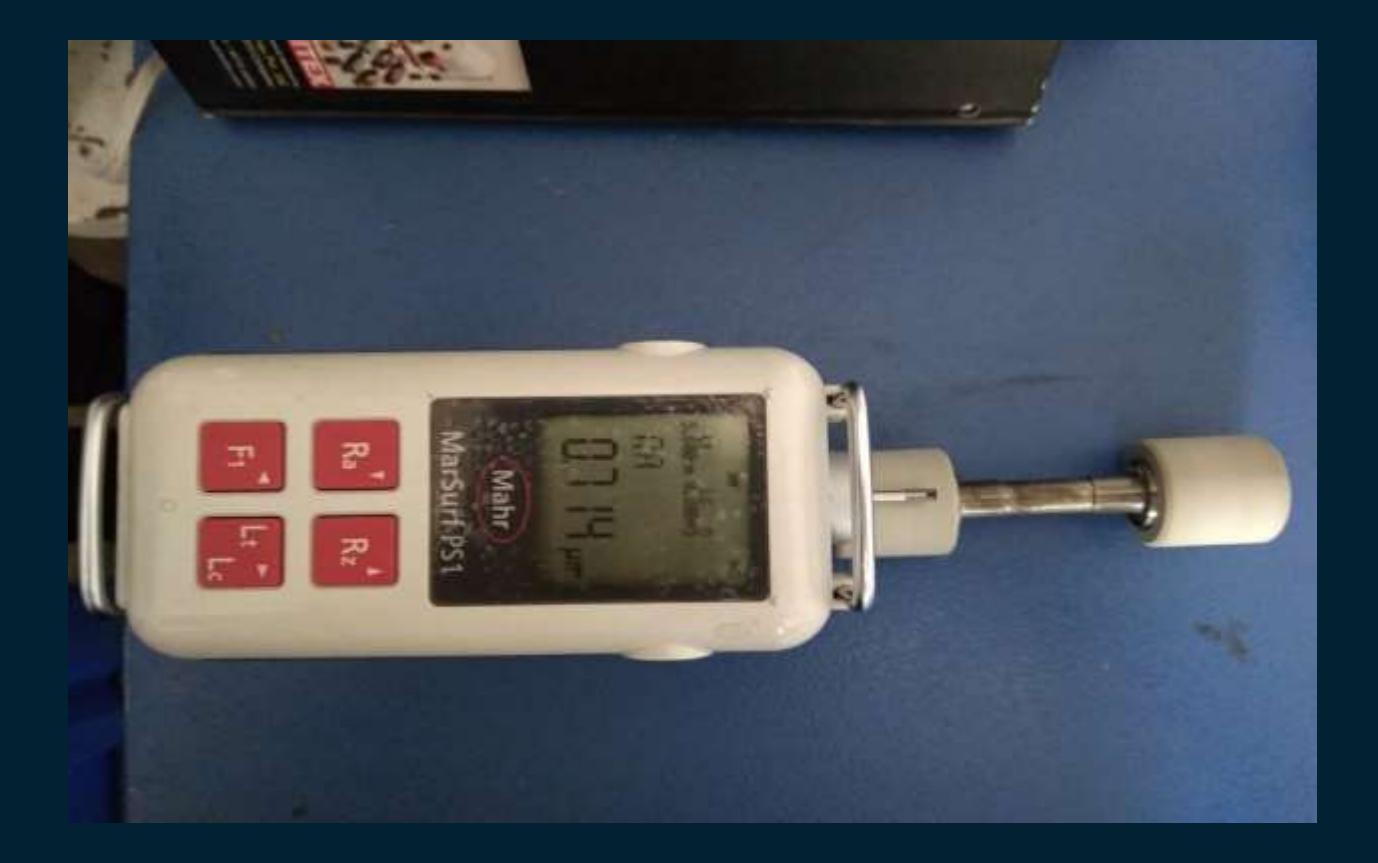
Ra Value of Cots – 6 seconds grinding time

- Grinding stone 80 grit and Speed is 2800 RPM
- Dressing of stone Once in 3 R/F s.
- Air cleaning of stone Once in 1 R/F.
- Spinning Cots Buffing Schedule 45 days once
- Buffing duration: 6 seconds
- Berkolising duration 9 minutes
- (Ra value of Spinning cots found 0.71 only)

- 1. Grinding time 6 seconds is enough to get optimum surface finish.
- 2. Dressing frequency of stone should be reduced to once in one machine.
- 3. Cleaning frequency of stone should be reduced to once in 50 shells.

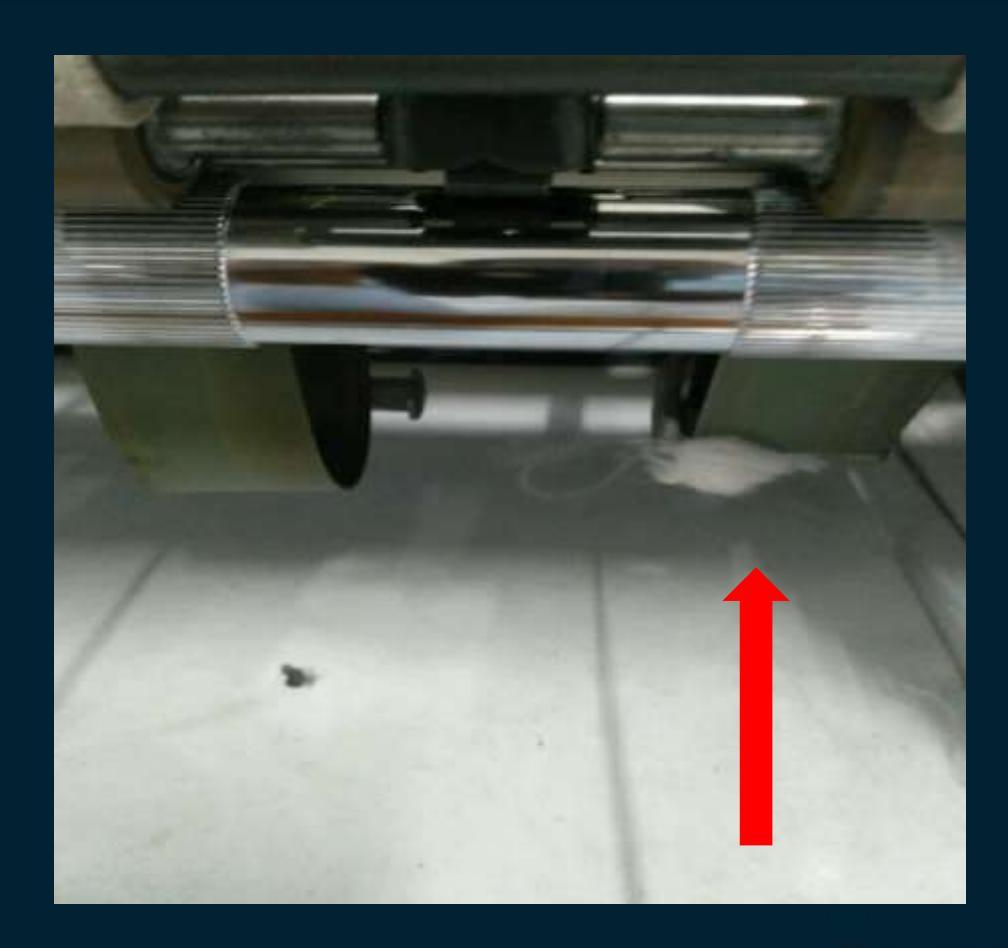
Fluff Accumulation on roving frame tension fork

- **1.** The tension fork spring is to be cleaned by rust removing solution frequently.
- 2. Frequency of cleaning to be increased with respect to removal of fluff accumulation on fork.
- 3. In LF 1400 A Simplex, the top aprons getting sliding from its original running position due to diameter reduction in the cradle roller. This will leads to yarn quality related issues.

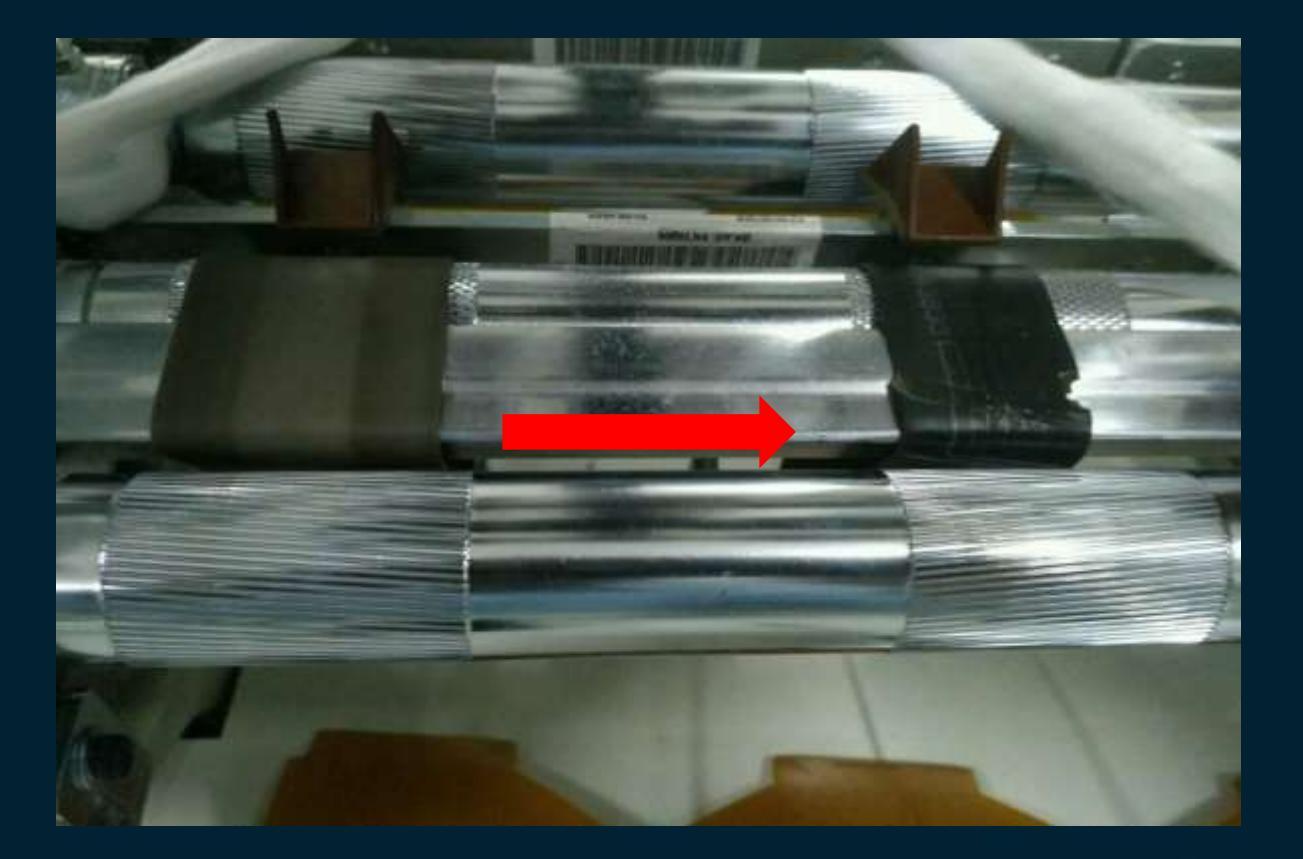
Roving frame Bottom Apron damages

- Present OD of the cradle roller is 24.5 mm only against its original diameter of 25.0 mm. So this 0.5 mm reduction will reflect nearly 1.6 mm loose in top apron length (0.5 X 3.14 = 1.6 mm).
- 5. By changing the cradle roller by new one, we can avoid this apron sliding issue.
- 6. Damaged and wrong size bottom aprons should be replaced by new and correct sizes.

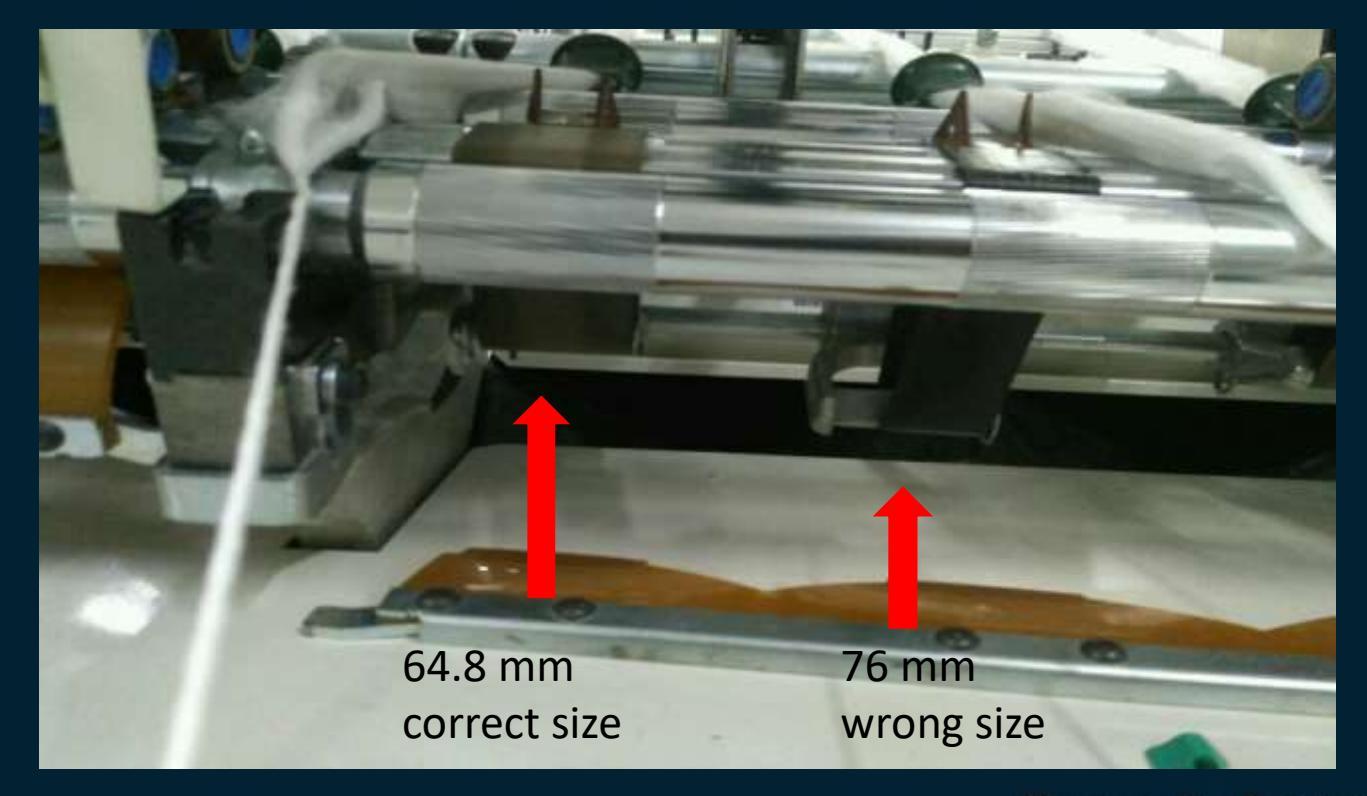
Different size Bottom Aprons running in Roving frame

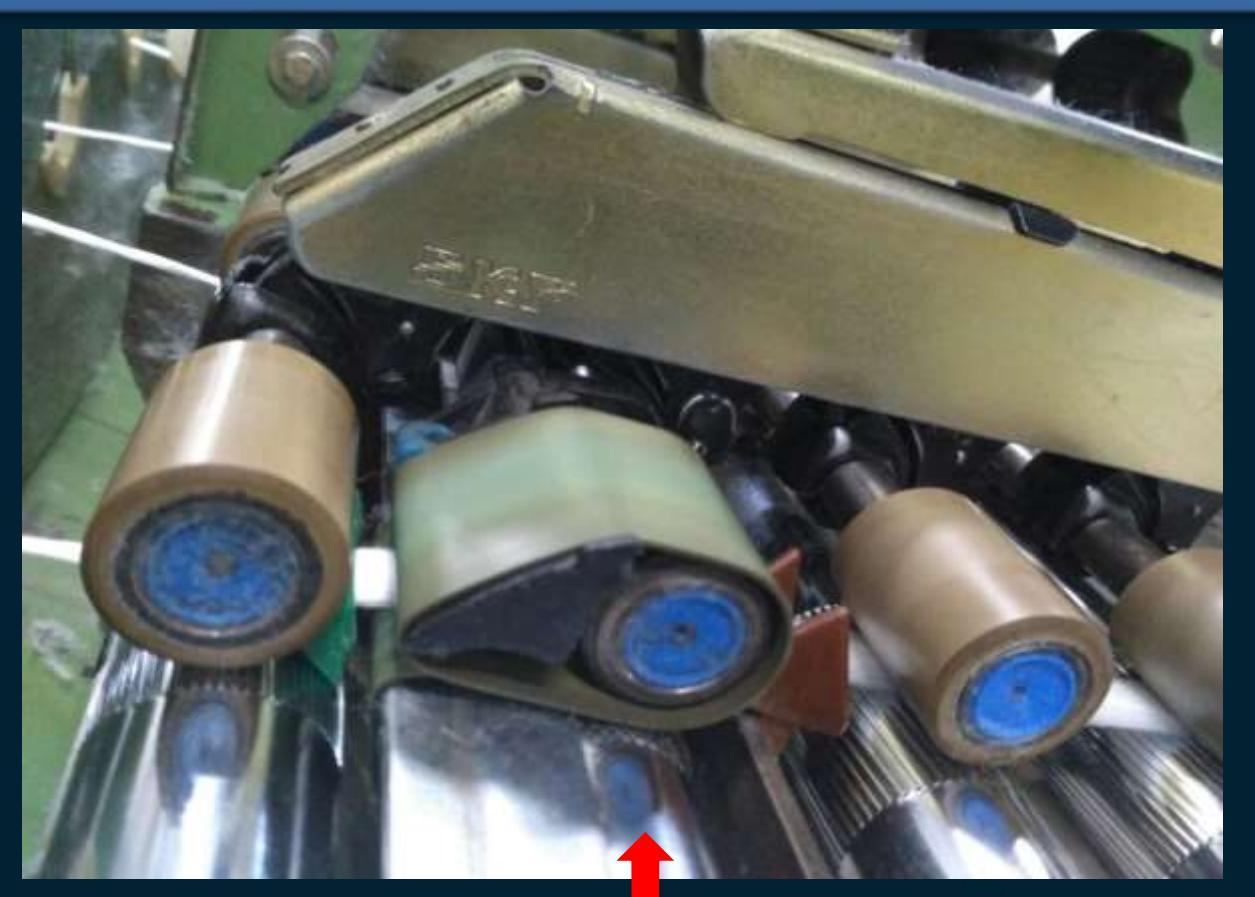
Top Apron sliding in roving frame

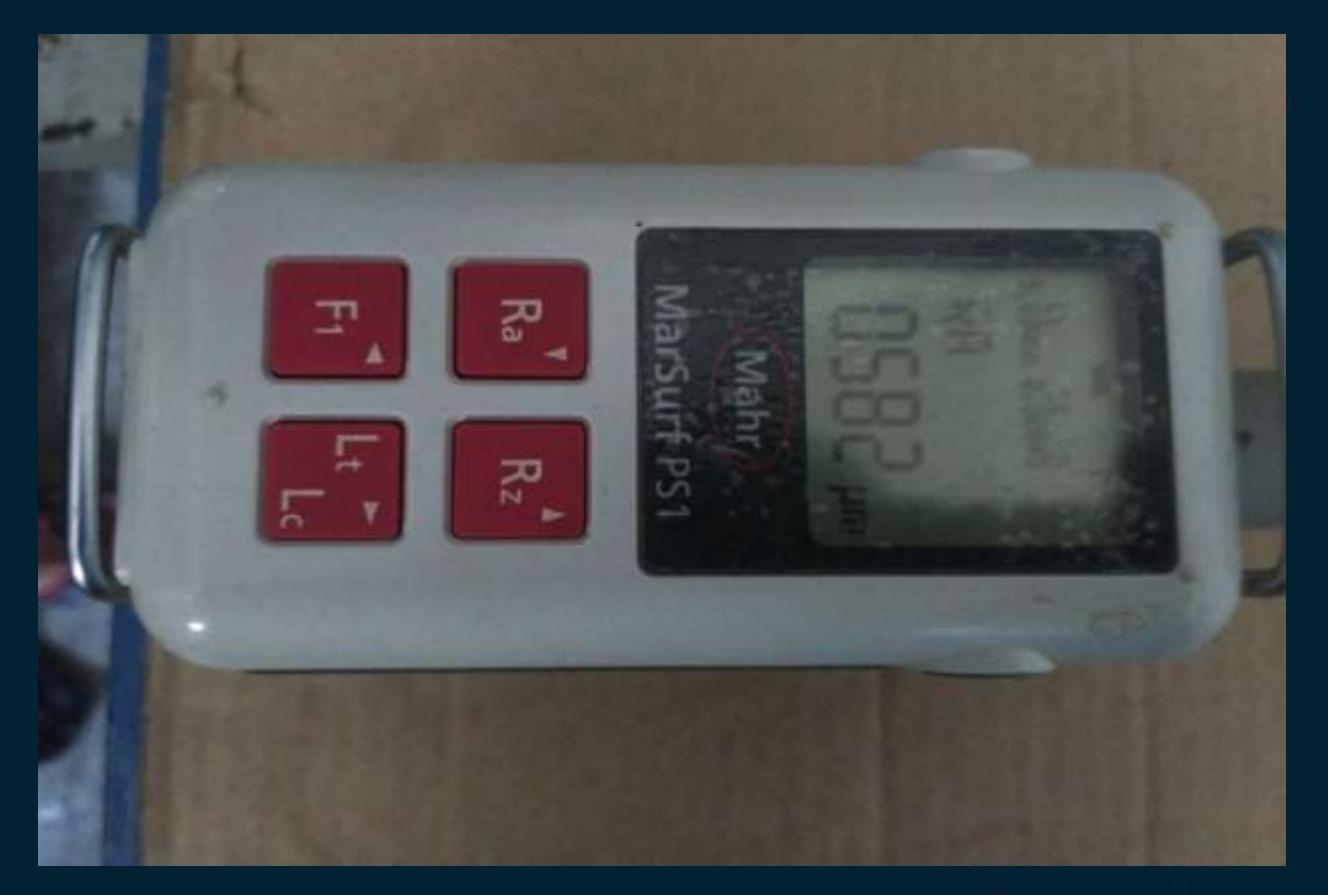
Simplex cot's surface finish

Surface finish of Simplex cots is 0.58 – 0.65 microns only which is well within norms. No need to change any buffing parameters related to Simplex.

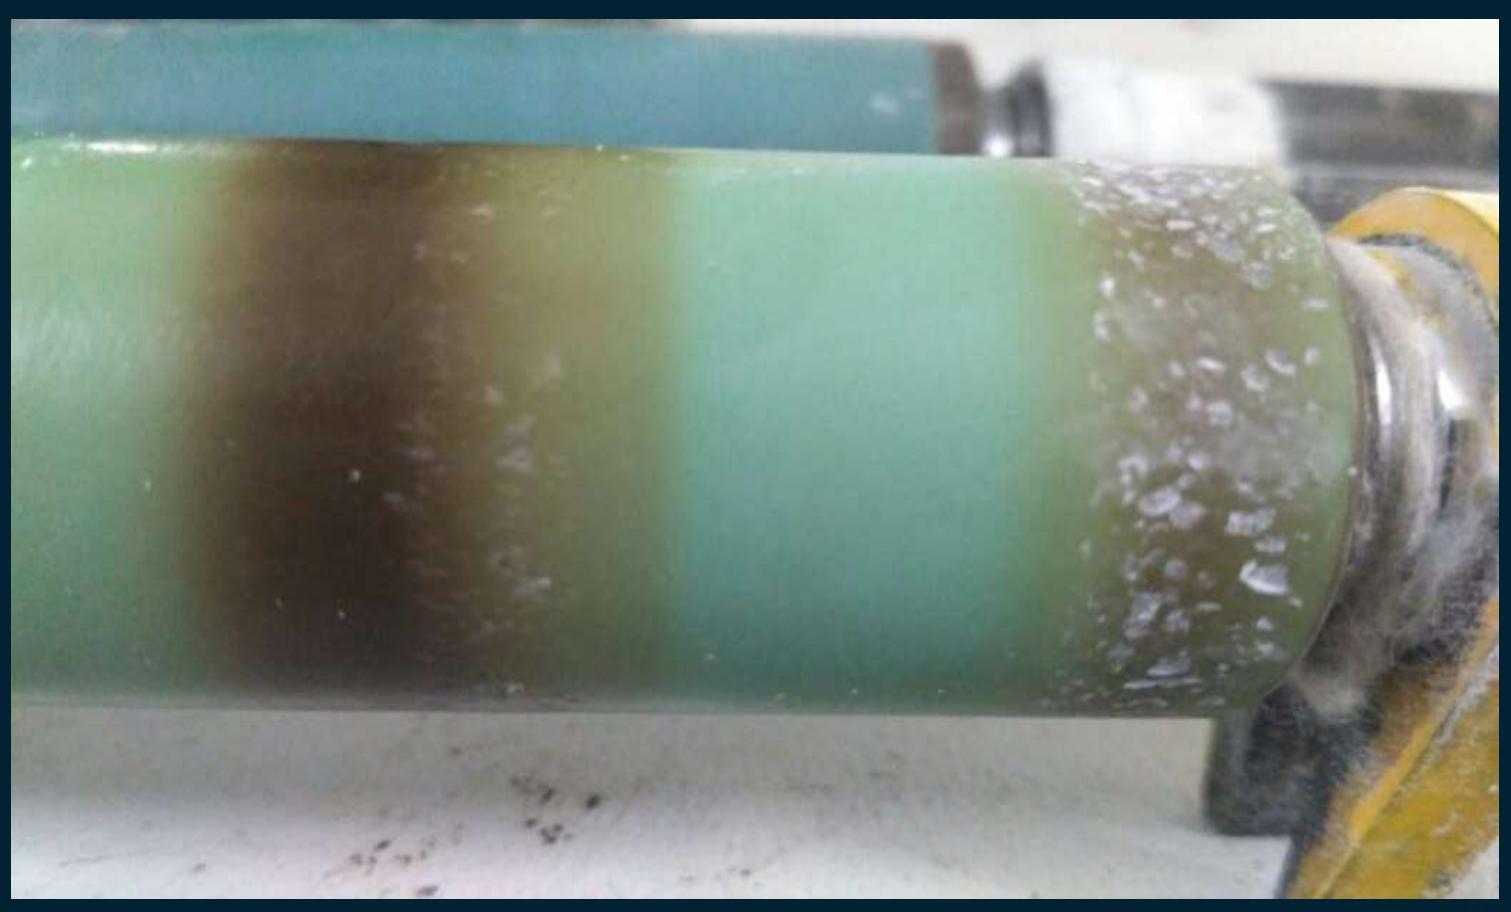
Drawing cot's fusion

PRECITEX HP SB 85 for 100% VSF process.

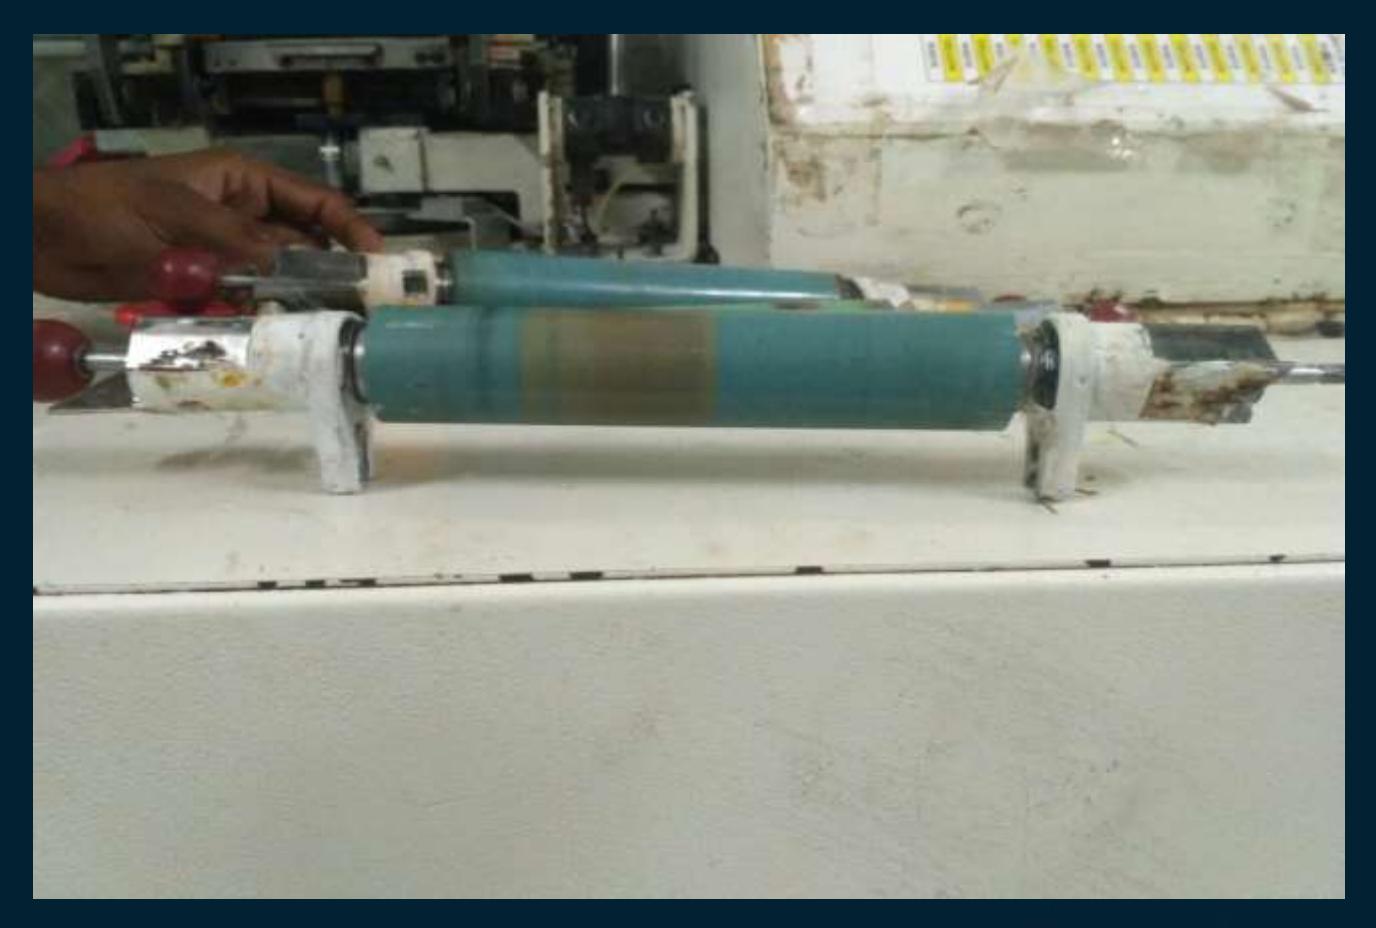
Drawing cot's fusion
